GEMINI DESIGN INFORMATION TEST PROGRAM

FINAL REPORT

85- AND 100-POUND-THRUST OAMS

THRUST CHAMBER ASSEMBLIES

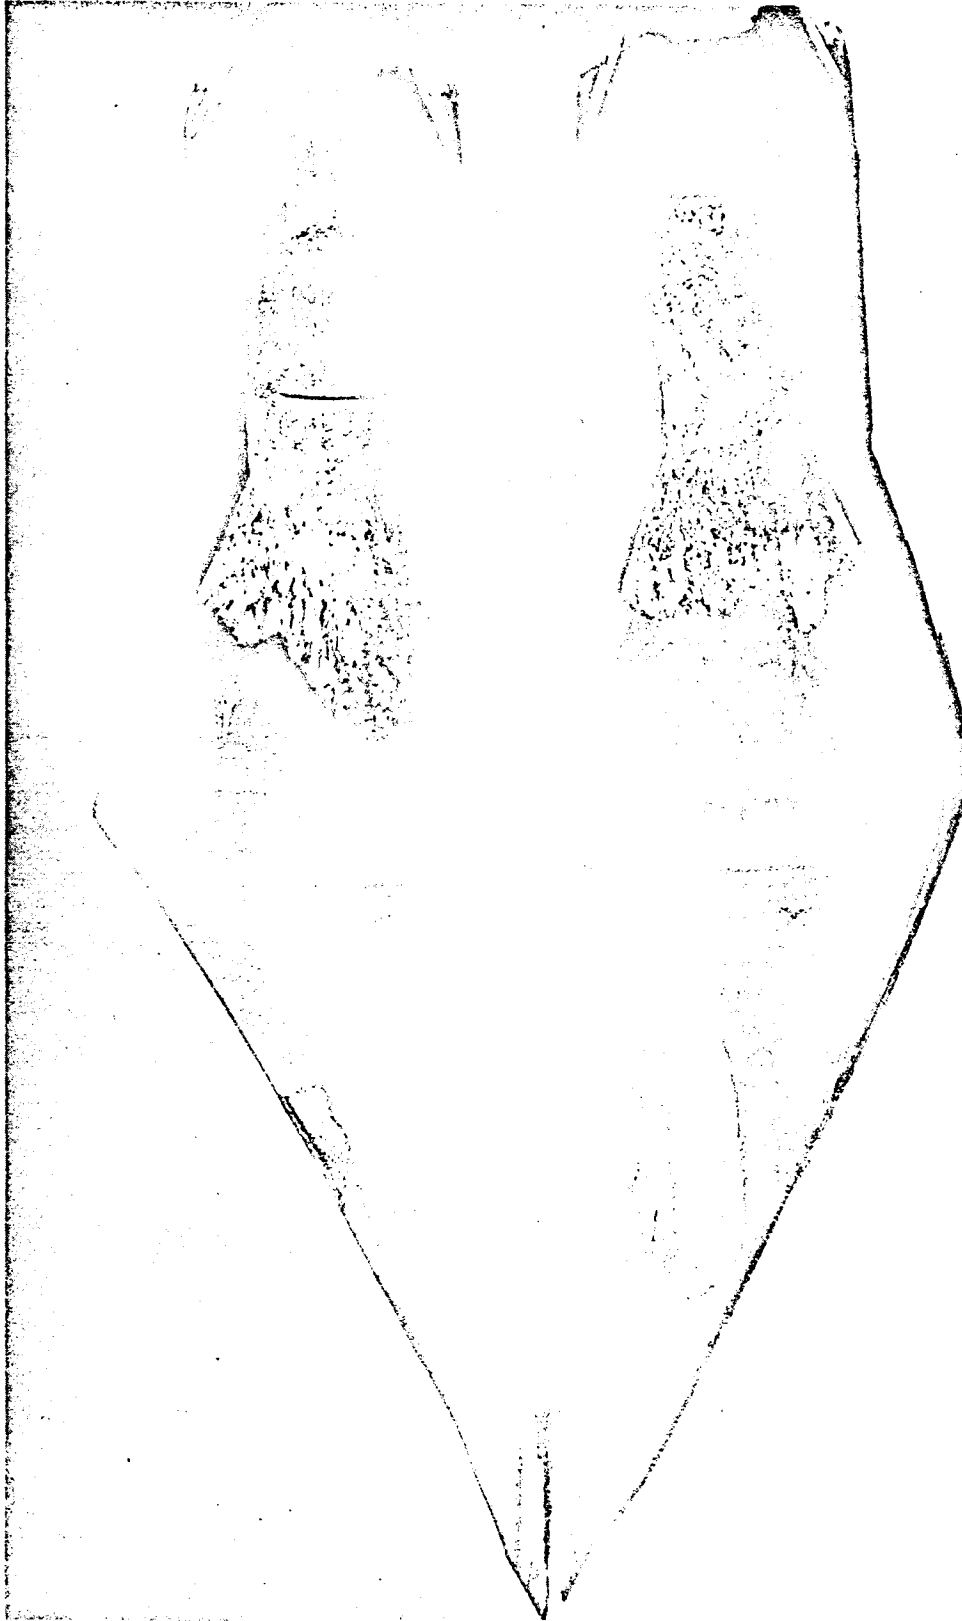
The test shows that the 85-pound-thrust TCA exceeds specification requirements. Further, it shows that the point of catastrophic failure is well beyond the specification requirement of 270 seconds. The sectioned chamber is shown in Fig. 6 of Appendix A. Although severely eroded, the erosion pattern is uniform, indicating a good injector spray pattern.

Figure 6. Sectioned TCA

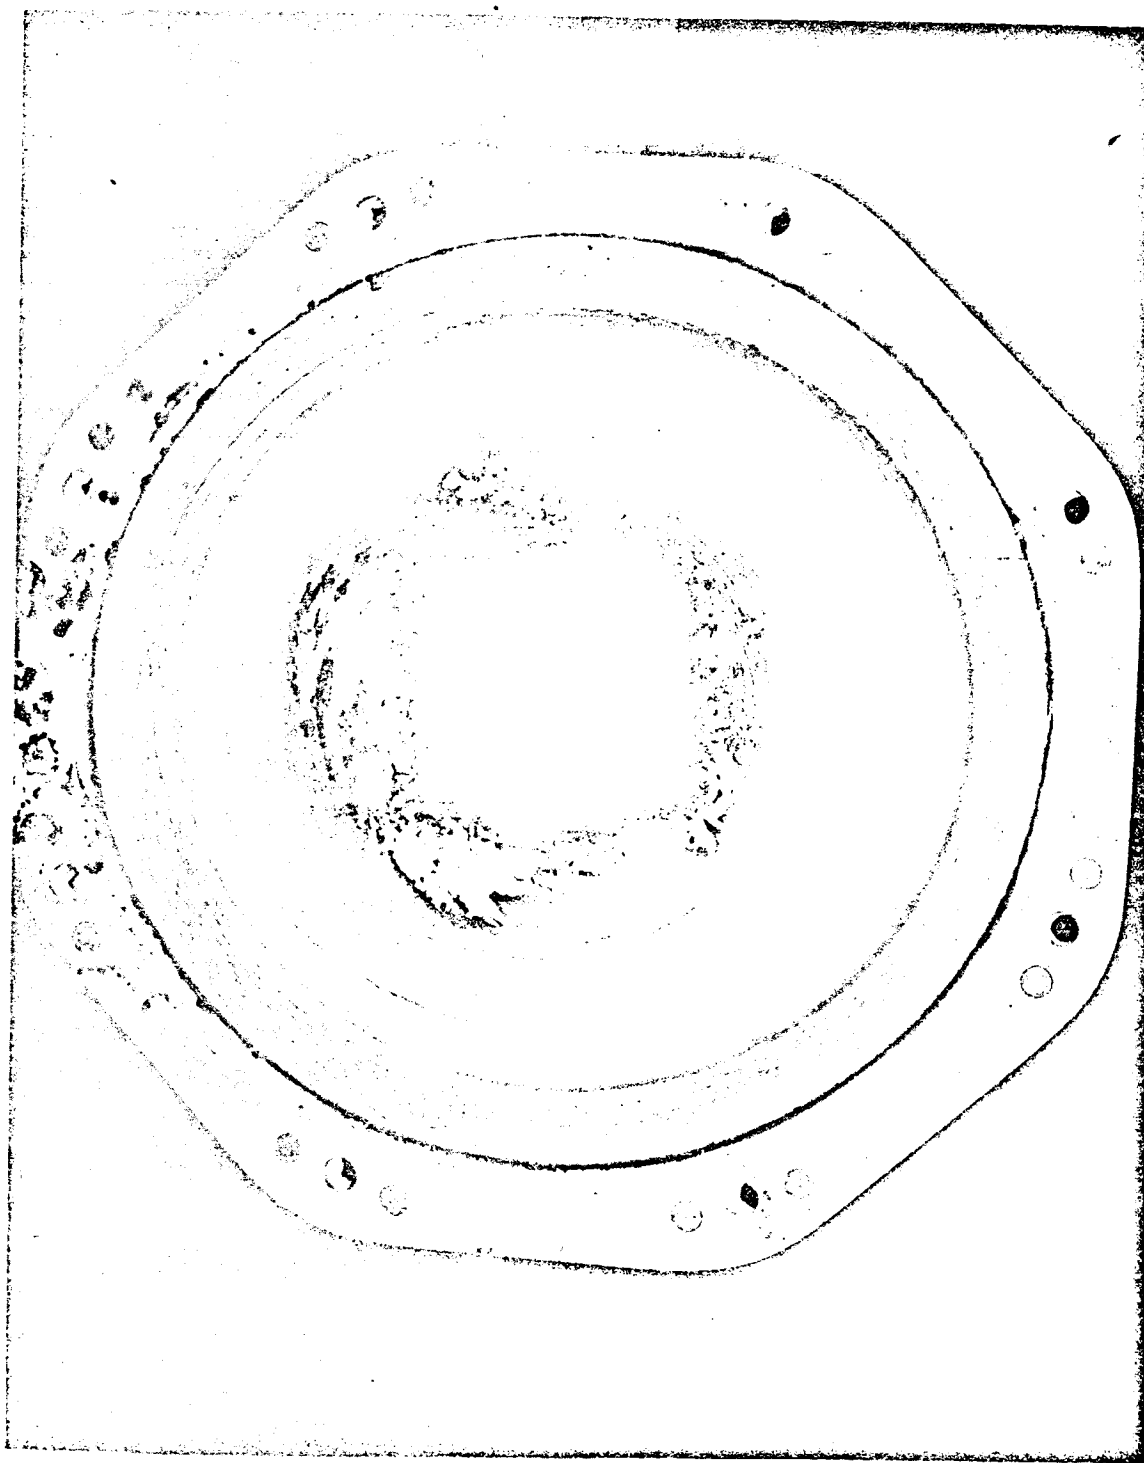
A posttest examination of the thrust chamber revealed two burnthrough areas at the injector end of the chamber. Also, there was uneven erosion in the combustion chamber and throat area. Part of the splashplate was burned away which affected the injector spray pattern and may have caused the uneven erosion of the combustion chamber. A detailed evaluation of the condition and probable cause of failure is contained in Appendix B. Despite the posttest condition of the TCA, there was no catastrophic failure (as defined) within the specification requirement.

Figure 12. Eroded Throat Area

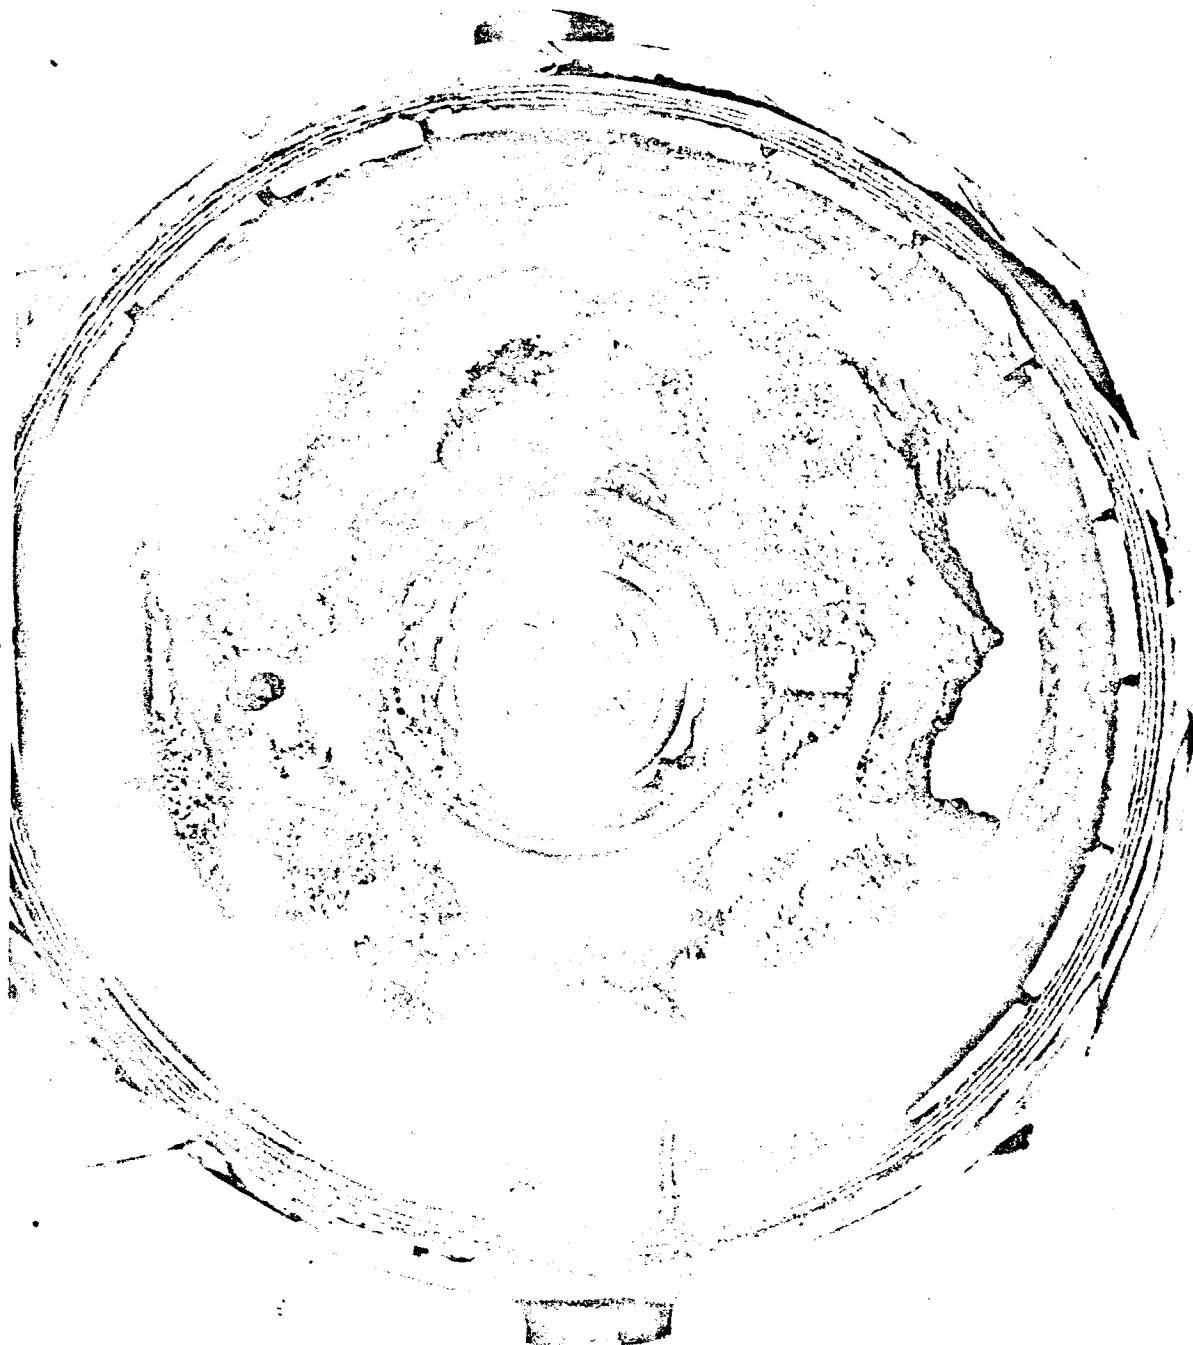
Figure 13. Injector-End Burnthrough Area

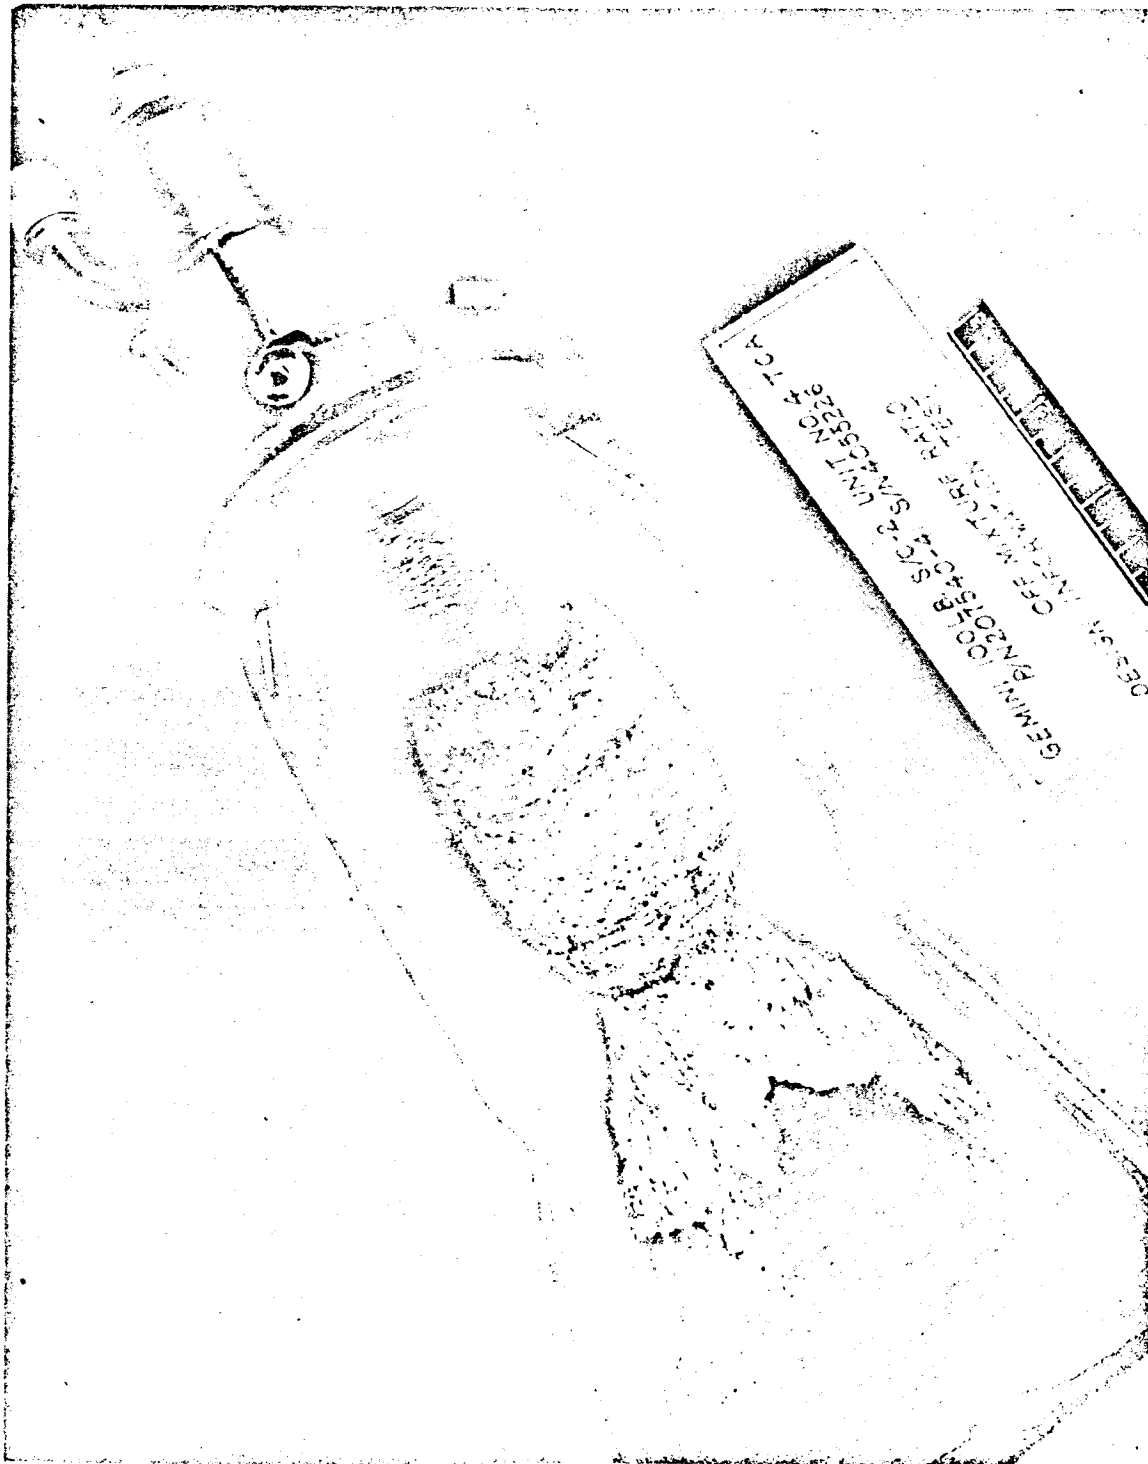
Figure 24. Postfire TCA

The specification maximum skin temperature of 600 F was exceeded during the off period between the fifth and sixth pulses of the MDC which occurred after 197 seconds of operation. The temperature increased gradually reaching a value of 750 F at cutoff at the completion of the final 95 seconds of steady-state operation following the MDC. Thrust and chamber pressure started to decay during the last 5 seconds of the first 15-second firing. Although the JTA liner and throat were consumed completely and the combustion zone was heavily glassed, the erosion was uniform and there was no burnthrough. The chamber was charred completely, but there were no severe delaminations.

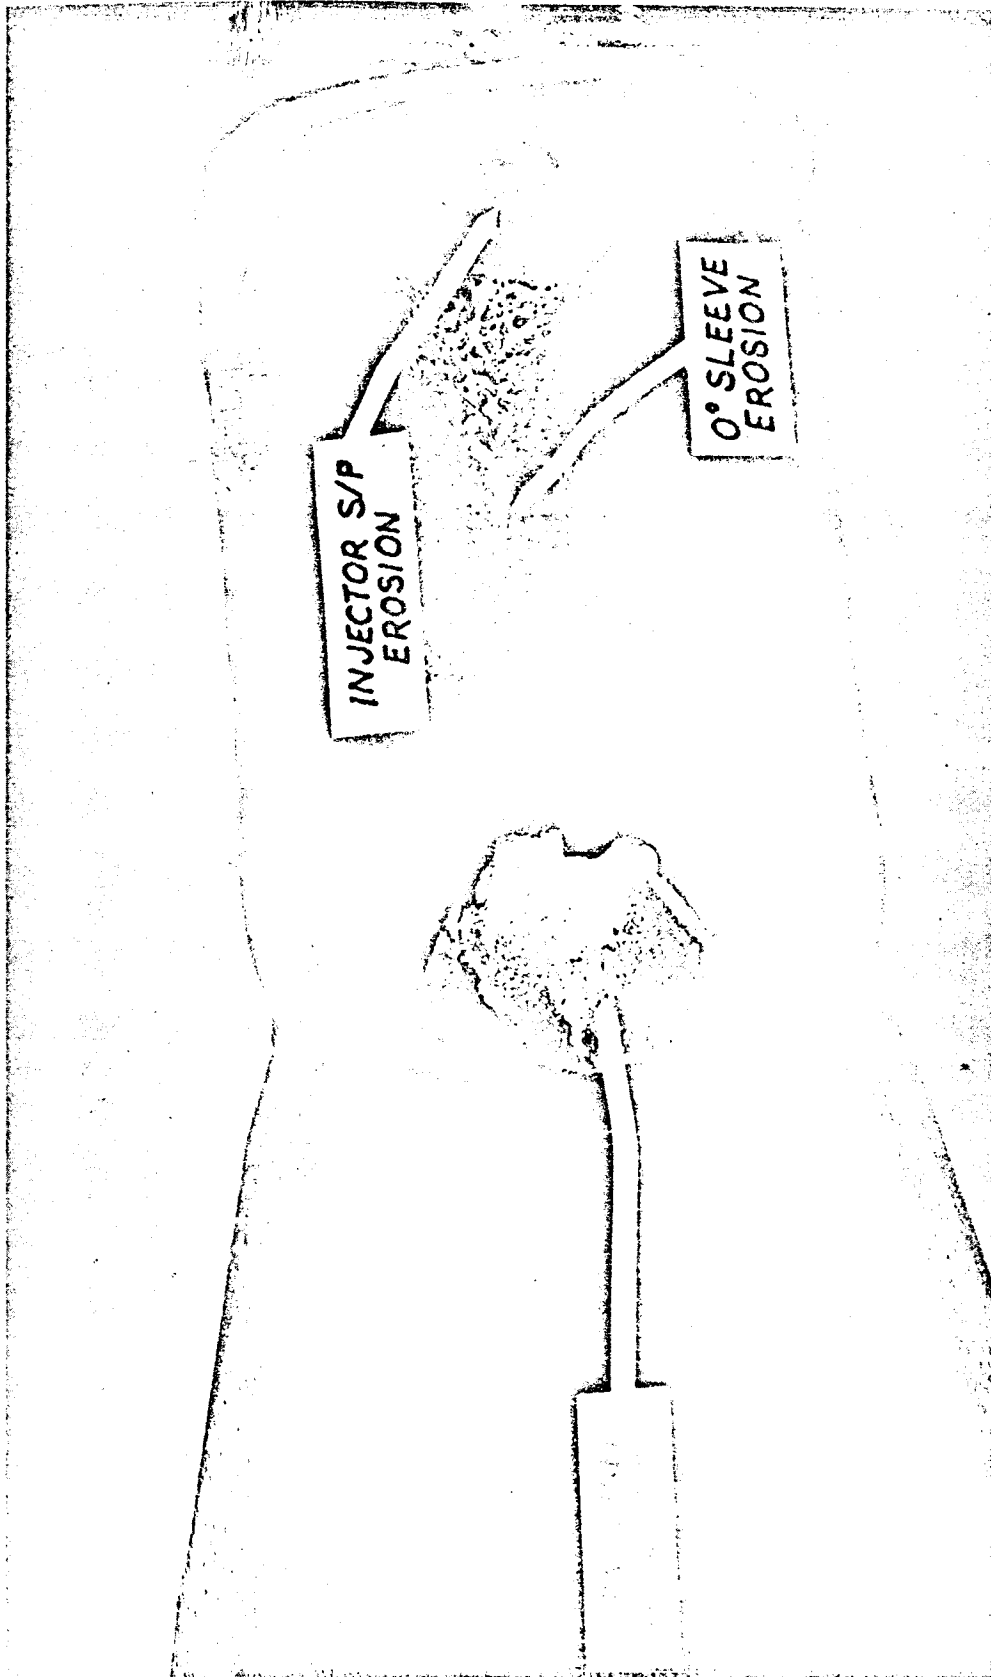
The test was completed satisfactorily and operation of the TCA was normal. However, posttest inspection disclosed erosion of the injector and six of the seven liner segments were missing. Heavy deposits of liner material were noted in the region immediately downstream of the throat. The throat insert had additional cracks but the minimum diameter was not eroded.

Figure 31. Combustion Chamber Erosion Areas

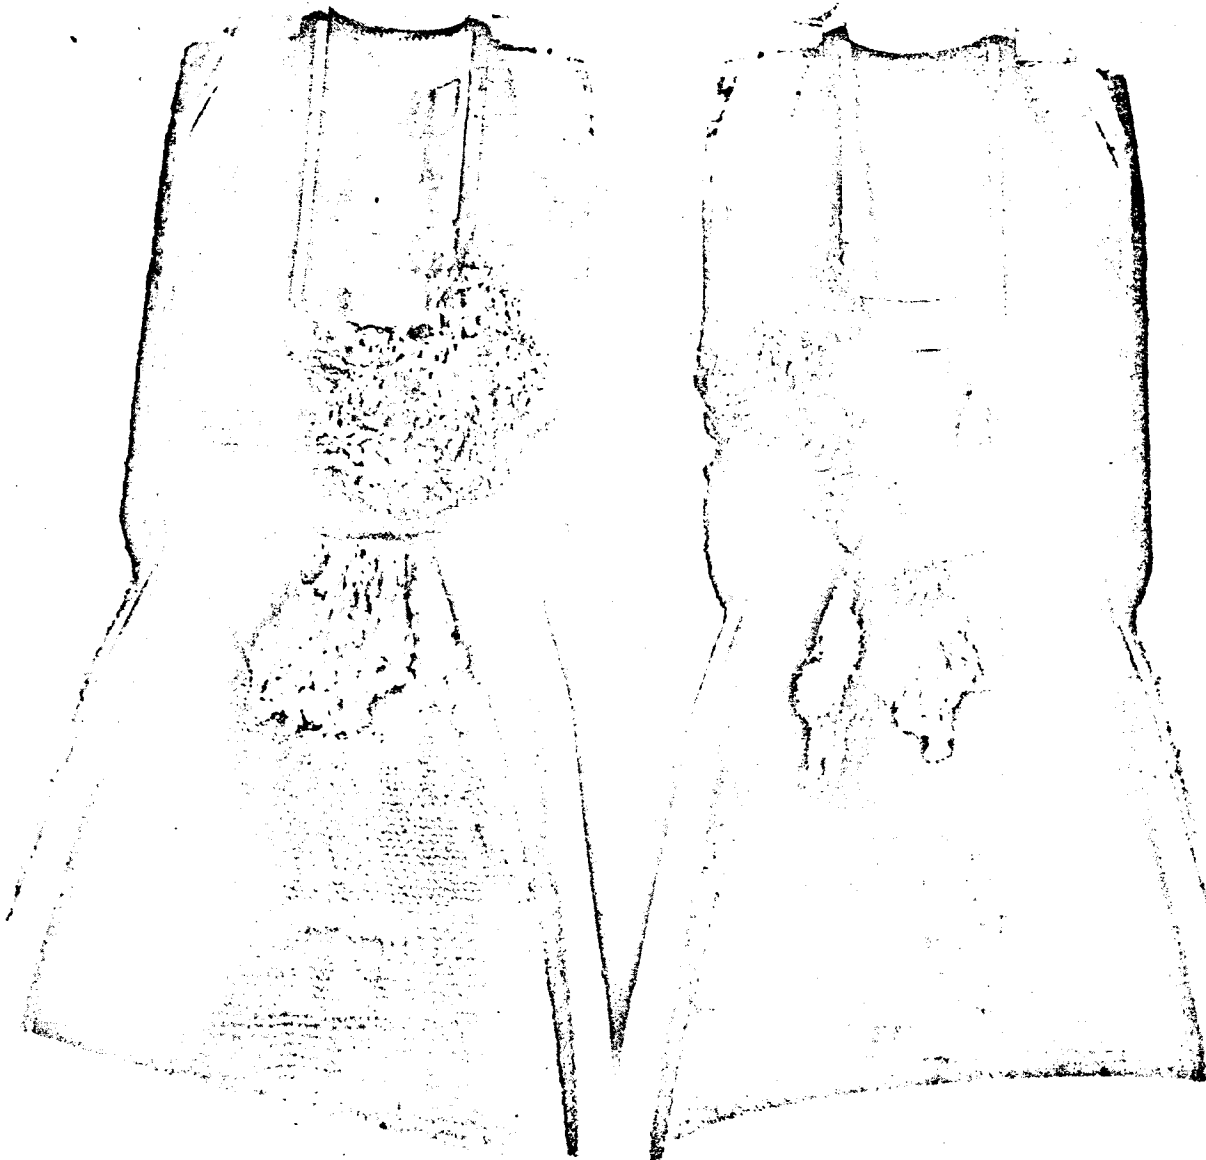
well as the edge of the last few liners. Minor delaminations were present in other parts of the ablative material. Deposits of JTA liner material were found at the throat exit. The skin temperature suddenly rose to 600 F during the steady-state firing at the end of the MDC. Burnthrough was also sudden and covered a large area. Total burn time was 370.86 seconds.

Figure 36. Material Buildup in Throat Section
